Name Of Dam: LAKE VIEW DAM
Location: CHESTERFIELD COUNTY
Inventory Number: VA. 04119

PHASE I INSPECTION REPORT

NATIONAL DAM SAFETY PROGRAM

LAKE VIEW DAM
CHESTERFIELD COUNTY, VIRGINIA
INVENTORY NO. 04119

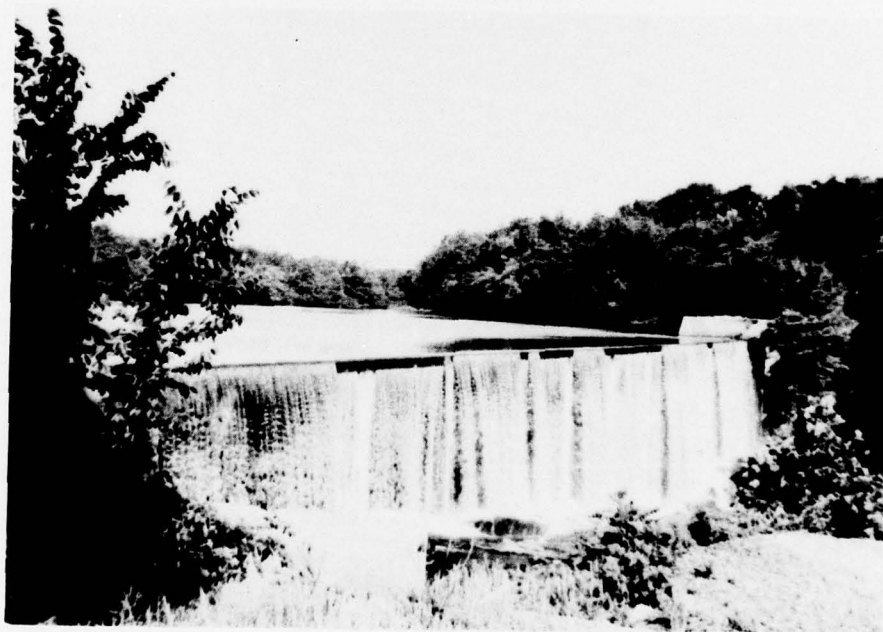
Front View of Dam

3.1.4 Spillway: At the time of inspection, water appeared to be flowing over the spillway crest at different elevations (see Photograph of the front view of the dam, page iii.) This may have been due to minor variations in the elevation of the crest of the spillway, however, the fact that water was flowing over the crest of the spillway made it difficult to accurately determine the cause for the irregularity of flow.

VISUAL EXAMINATION OF	OBSERVATIONS	REMARKS OR RECOMMENDATIONS
CONCRETE WEIR	Spillway crest, water falls about 1 inch in some places unevenly.	See photo page iii.
APPROACH CHANNEL	Natural stream.	
DISCHARGE CHANNEL	Natural stream.	
BRIDGE AND PIERS	In good condition.

- (1) The numerous leaks and cracks in the dam as shown on Plate No. 1, Appendix I.
- (2) The weathered bedrock in the panels right of the spillway.
- (3) The possible deterioration of the spillway crest.

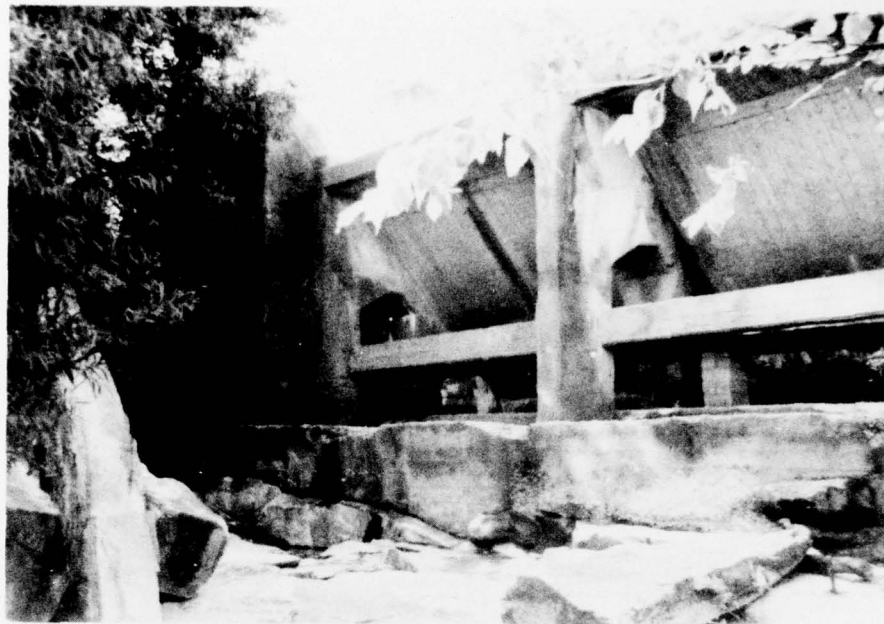
PHOTOGRAPH NO. 1
Right Abutment
and
Part of Concrete Structure

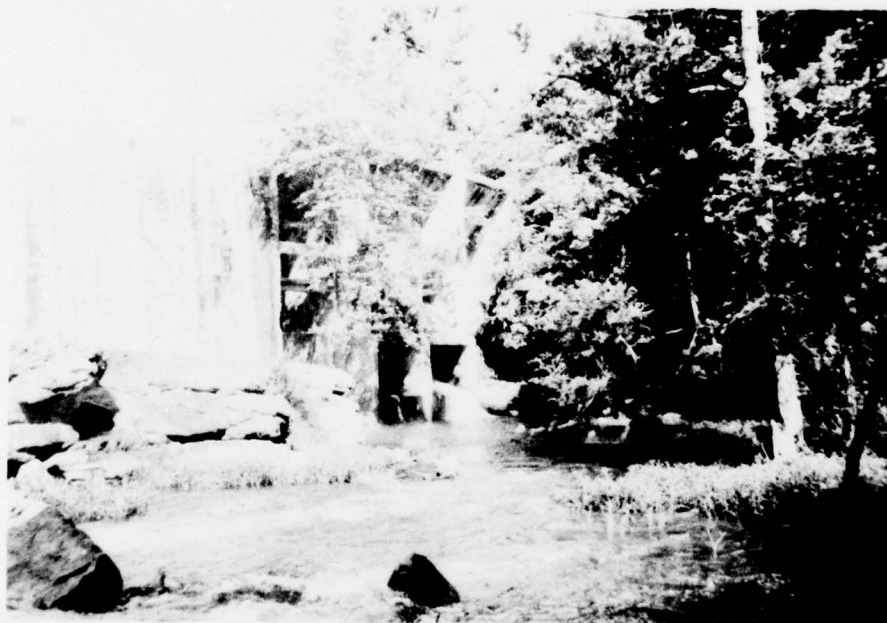
PHOTOGRAPH NO. 2
Left Abutment
and
Part of Concrete Structure

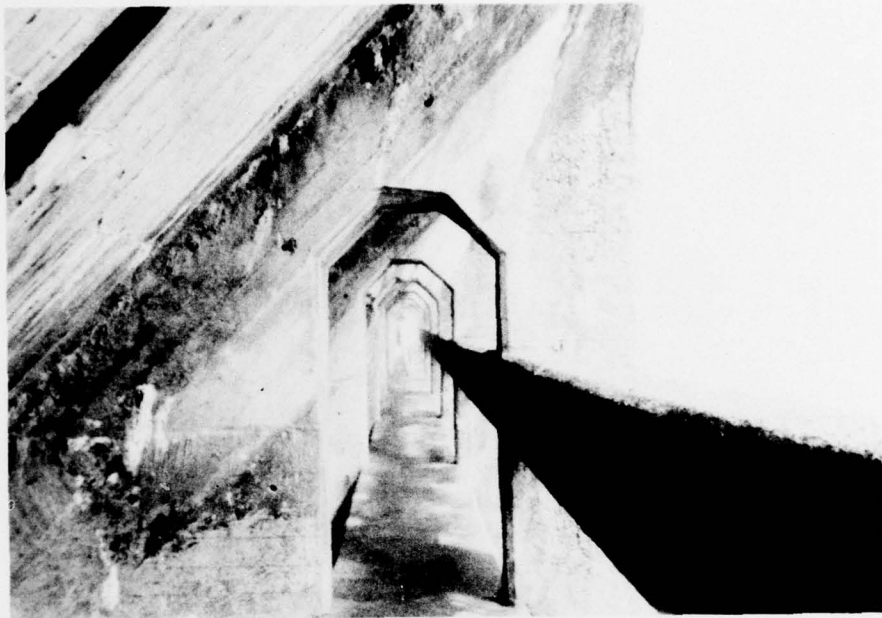
PHOTOGRAPH NO. 3
Catwalk

1.2.1 Dam and Appurtenances: The Lake View Dam is a concrete dam 418 feet long and 38.6 feet high with a crest elevation of 60.6 feet.* The upstream slope of the dam is 1(H):1(V). The downstream side of the dam has a system of walls, normal to the crest, on 18-foot centers. These walls have concrete struts between them and openings through which a walkway passes, just behind the crest of the dam (see Appendix II, Photograph No. 3).

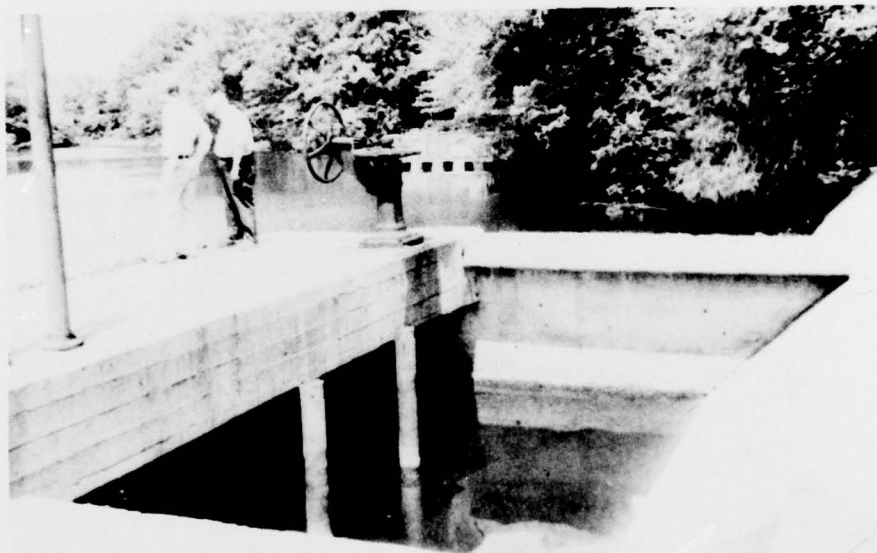
PHOTOGRAPH NO. 4
Slide Gate

VISUAL EXAMINATION OF	OBSERVATIONS	REMARKS OR RECOMMENDATIONS
CRACKING AND SPALLING OF CONCRETE SURFACES IN OUTLET CONDUIT	N/A	
INTAKE STRUCTURE	Concrete structure near left abutment with a slide gate.	See photograph No. 4, Appendix II.
OUTLET STRUCTURE		
OUTLET CHANNEL	The natural stream.	
EMERGENCY GATE	Slide gate.	Not completely closed at time of inspection - flow estimated at over 5 gpm/

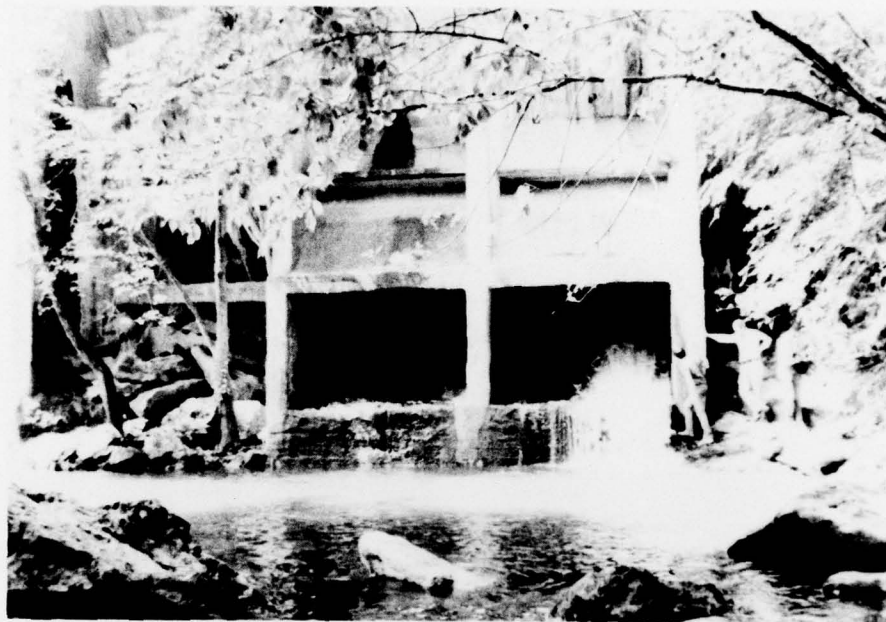
PHOTOGRAPH NO. 5
Discharge from Slide Gate

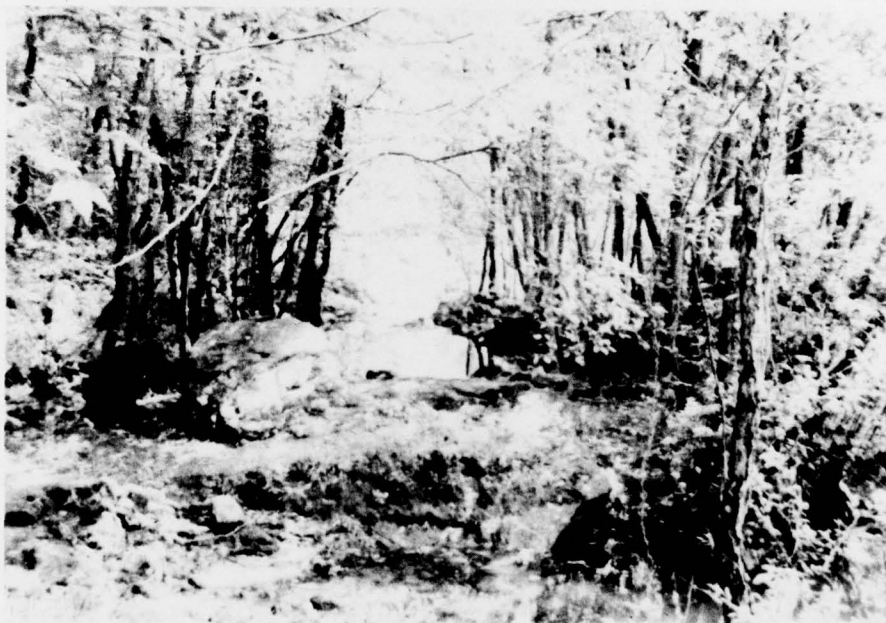
PHOTOGRAPH NO. 6
Downstream

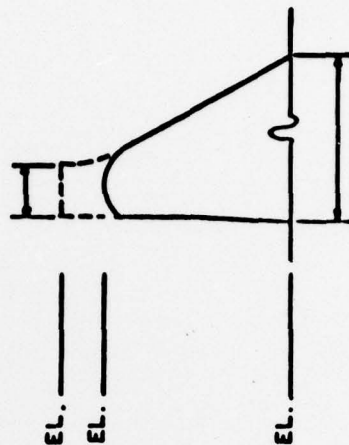
LOADING CASE	ELEV. HEAD WATER	ELEV. TAIL WATER	ΣV	ΣH	$\frac{\Sigma H}{\Sigma V}$	LOCATION RESULTANT FROM TOE	% BASE IN COMPRESSION	FACTOR SAFETY SLIDING	FOUNDATION PRESSURE	
									TOE	HEEL
NORMAL POOL	55.6	24.0*	36.5 ^k	35.3 ^k	0.97	16.8'			1.1 ksf	1.1 ksf
1/2 PMF	70.5	45.0	28.0 ^k	57.0 ^k	2.04	18.5'			0.6 ksf	1.1 ksf

THIS ANALYSIS IS BASED ON THE ASSUMED GEOMETRIC CONFIGURATION SINCE NO DRAWINGS WERE AVAILABLE TO VERIFY THE DIMENSIONS OF THE DAM.
